Update "With-Site-Visit" Reserve Study

Wiggins Bay Foundation, Inc. Naples, FL

Report #: 23210-0
For Period Beginning: January 1, 2018
Expires: December 31, 2018

Date Prepared: October 25, 2017

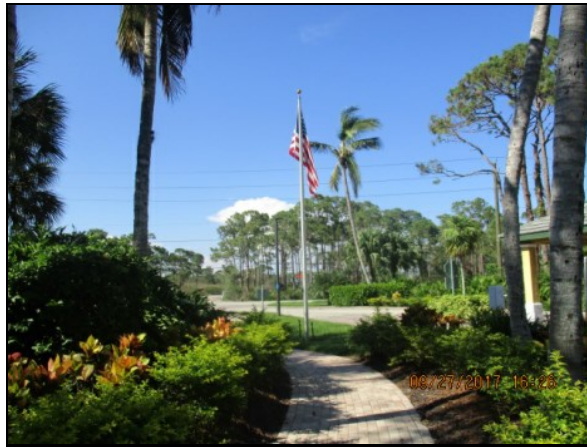
Comp #: 2107 Concrete Sidewalks - Repair

Evaluation: No quantity provided. Costs are based on repairs to 200 LF limited portion only.

Fair condition: Concrete sidewalks determined to be in fair condition typically exhibit minor changes in slope and a moderate percentage of cracking and surface wear. Trip hazards may be increasing in frequency and severity and should be closely monitored to prevent further risks.

Repair any trip and fall hazards immediately to ensure safety. As routine maintenance, inspect regularly, pressure wash for appearance and repair promptly as needed to prevent water penetrating into the base and causing further damage. In our experience, larger repair/replacement expenses emerge as the community ages, especially as trees adjacent to sidewalks continue to grow. Although difficult to predict timing, cost and scope, we suggest a rotating funding allowance to supplement the operating/maintenance budget for periodic larger repairs. Adjust as conditions, actual expense patterns dictate within future Reserve Study updates.

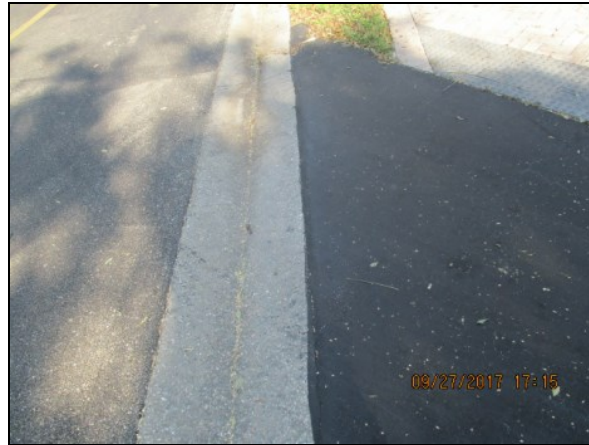
Comp #: 2109 Concrete Curbs & Gutters - Repair

History: Associations plans to conduct repairs to 12 sections of concrete valley gutter (112 LF) for \$3,645 in 2018, according to the Manager's provided bid.

Evaluation: No quantity provided. Costs are based on repairs to 200 LF limited portion only.

Fair condition: Concrete curbs and gutters determined to be in fair condition typically may start to exhibit minor hair-line cracks and minimal vehicle damage, particularly in high-traffic areas.

Although complete replacement of all areas together should not be required, conditions observed merit inclusion of an allowance for ongoing repairs and partial replacements. Timeline and cost ranges shown here should be re-evaluated during future Reserve Study updates.

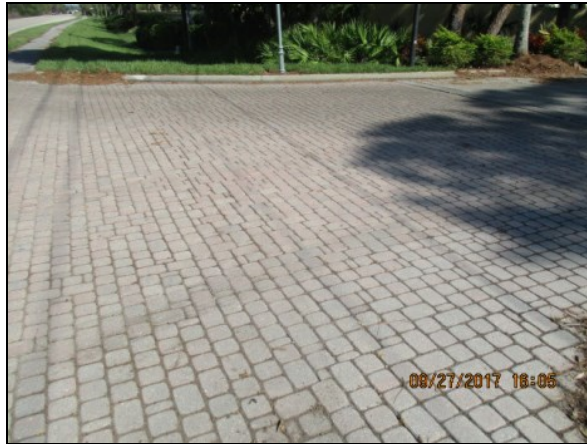
Comp #: 2119 Pavers (Roadways) - Replace

Fair condition: Paver roadways and/or parking sections determined to be in fair condition typically exhibit some amount of minor displacement, lifting and tripping hazards, most often in high-traffic areas. Signs of wear and age are evident, but not advanced. Overall appear to be aging normally.

As routine maintenance, pavers should be inspected to identify any physical issues such as lifting, cracking, and excessive surface wear. We recommend maintaining a small amount of spare pavers on site for replacement in the event of breakage. At long intervals, sunlight, weather and vehicle traffic can degrade the condition of the material, requiring replacement for structural and/or aesthetic reasons. Schedule shown here may be updated based on the aesthetic preferences of the association and standards in the local area. Some associations choose to apply a sealer coat, which may help preserve and/or enhance aesthetic appeal.

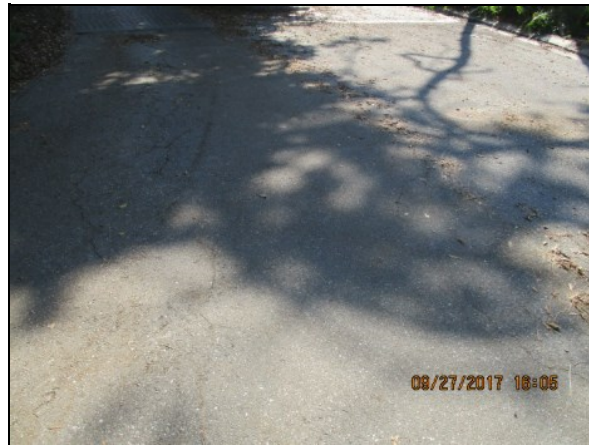
Comp #: 2123 Asphalt - Seal/Repair

Evaluation: Poor condition: Asphalt seal-coat determined to be in poor condition is typically not uniform, and may be very light in color, especially in higher-traffic areas. Traffic markings do not contrast well with pavement and are faded and worn.

POST-RESURFACE: Seal-coating is recommended, but only after completion of asphalt resurfacing in order to obtain a good return on investment. Remaining useful life shown here is intended to cycle initial application one year later than remaining useful life shown for asphalt resurfacing as noted elsewhere in this study. Typical vendor and manufacturer recommendations call for initial application roughly 6-12 months following repaving/resurfacing. Asphalt should then be re-sealed at recurring intervals based on the useful life shown for this component.

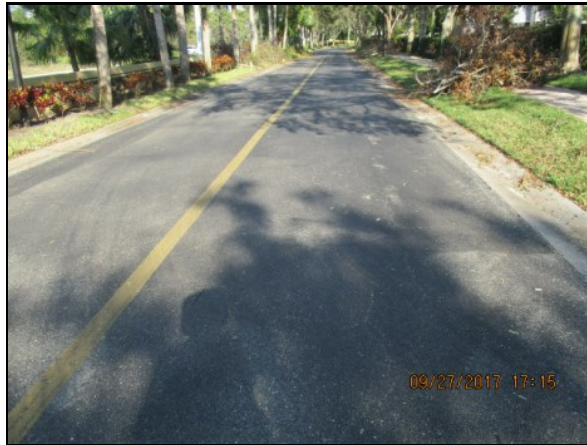
Evaluation: Quantities are per quote provided. Poor condition: Asphalt pavement determined to be in poor condition typically exhibits more substantial, consistent patterns of wear and age, including longer, wider cracks and/or patterns of cracking.

As routine maintenance, keep roadway clean, free of debris and well drained; fill/seal cracks to prevent water from penetrating into the sub-base and accelerating damage. Even with ordinary care and maintenance, plan for eventual large scale resurface (milling and overlay of all asphalt surfaces is recommended here, unless otherwise noted) at roughly the time frame below. Take note of any areas of ponding water or other drainage concerns, and incorporate repairs into scope of work for resurfacing. Our inspection is visual only and does not incorporate any core sampling or other testing, which may be advisable when asphalt is nearing end of useful life. Some communities choose to work with independent paving consultants or engineering firms in order to identify any hidden concerns and develop scope of work prior to bidding. If more comprehensive analysis becomes available, incorporate findings into future Reserve Study updates as appropriate.

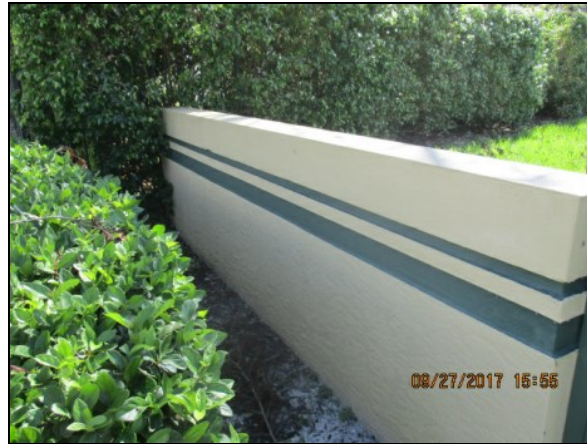
Comp #: 2157 Perimeter Walls - Repair/Paint

Evaluation: Approximately 5-feet tall. Quantity of paint for gatehouse is incidental. Condition based on RUL: Poor condition:

Perimeter walls determined to be in poor condition typically exhibit more advanced surface wear, and easily noticeable inconsistent color/texture or staining. Curb appeal is usually affected at this stage. In advanced cases, cracking and/or other structural concerns may be widespread and additional repairs may be required prior to painting.
