**Traditional Reserve Study
For
Wiggins Bay Foundation Inc.
Naples, Florida
September 18, 2025**

Report Number: 2026.09.18.412

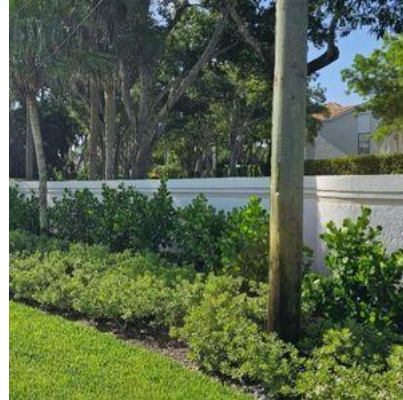
Wall, concrete

- **Concrete Wall, Rebuild, Partial** – There is approximately 14,825 square feet of concrete wall. It is in good condition. The estimated remaining useful life is 65 years and so the total replacement cost is excluded from the study. A periodic failure rate of 5% every 3 years is included in the study as the estimated costs are significant.

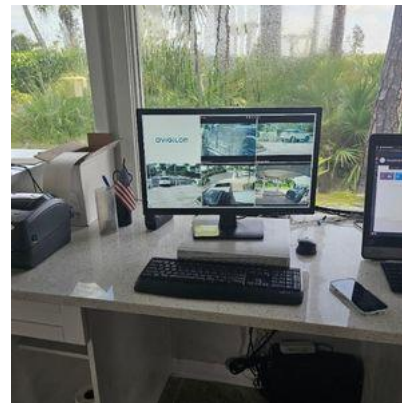
ID: 2

Security cameras

- **Security System, Allowance** – This is an allowance for the repair and replacement of the security systems. This includes cameras, barrier arm gates, and access panels. They are in good condition.

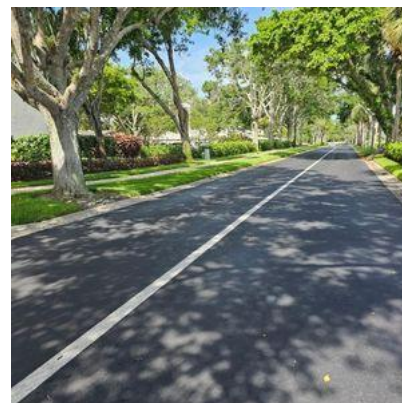
ID: 3

Asphalt pavement

- **Asphalt Pavement, Crack Repair, Seal and Coat** – There is approximately 15,513 square yards of asphalt pavement seal and coat. It is in fair condition.

- **Asphalt Pavement, Mill and Overlay** – There is approximately 15,513 square yards of asphalt pavement mill and overlay. It is in fair condition.
- **Concrete Wall, Painting and Waterproofing** – There is approximately 29,650 square feet of painting and waterproofing for the concrete walls. It is in great condition.

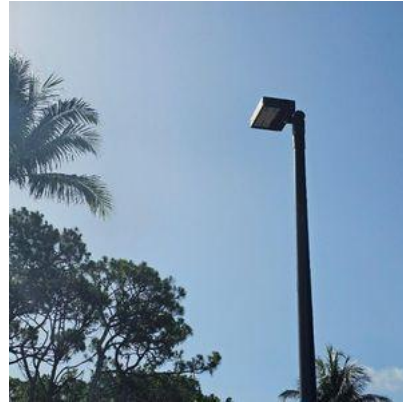
ID: 4

Exterior lighting

- **Entrance Signs** – This is an allowance for the maintenance and repair of the entrance signs. They are in good condition.
- **Exterior Lighting** – This is an allowance for the general maintenance of the property lighting including light poles and fixtures. They are in good condition.

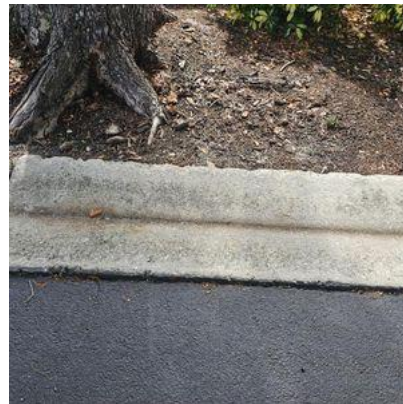
ID: 5

- **Road Gutters and Curbs, Concrete, Partial** – There are approximately 12,068 linear feet of concrete road gutters and curbs. Overall, it is in fair condition with some areas showing cracks.

Road gutters, concrete

The estimated remaining useful life is 50 years and so the total replacement cost is excluded from the study. A periodic failure rate of 5% every 3 years is included in the study as the estimated costs are significant.

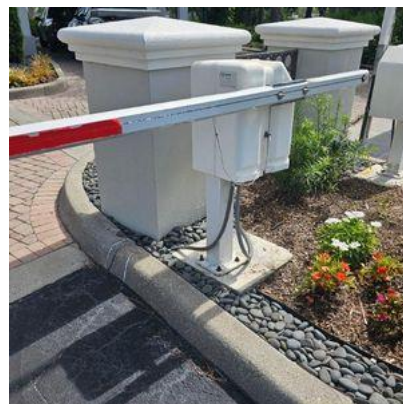
ID: 6

Barrier arm operator

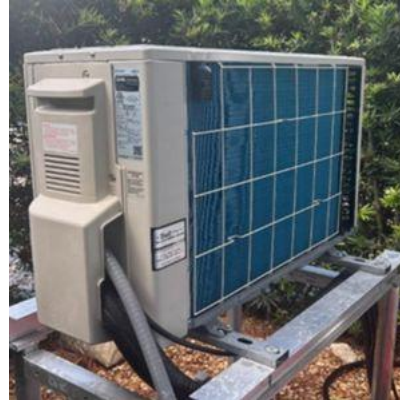
ID: 7

HVAC unit

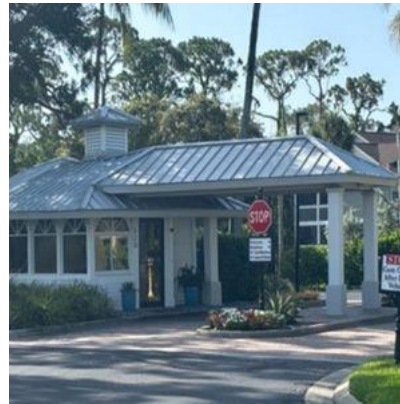
ID: 8

Security building

- **Painting and Waterproofing** – There is approximately 1,464 square feet of exterior painting and waterproofing for the security building. It is in good condition.
- **Roof, Metal** – There is approximately 12 squares of metal roofing. It is in great condition.
- **Security Building Renovation, Allowance** – This is an allowance for the interior renovations of the security building. It is in great condition.
- **Security Building, HVAC 1.5 Ton** – There is one 1.5-ton mini split HVAC system for the security building. It is in great condition.

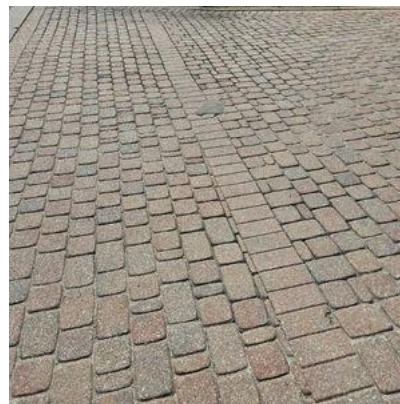
ID: 9

Brick pavers

- **Pavers, Brick, Partial** – There is approximately 16,870 square feet of brick pavers. It is in good condition. The estimated remaining useful life is 65 years and so the total replacement cost is excluded from the study. A periodic failure rate of 5% every 3 years is included in the study as the estimated costs are significant.

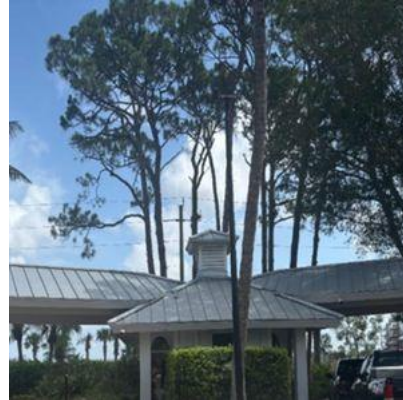
ID: 10

Metal roof
